Pro C5200s/C5210s

Operating Instructions

Troubleshooting: TCRU/ORU

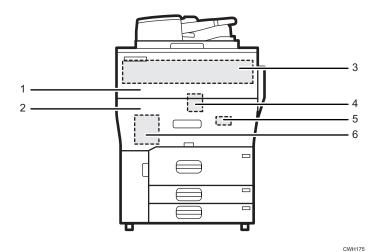
- 1. Toner Unit
- 2. Drawer
- 3. Photoconductor Unit
- 4. Cleaning Unit for Intermediate Transfer Belt
- 5. Transfer Unit
- 6. Fusing Unit

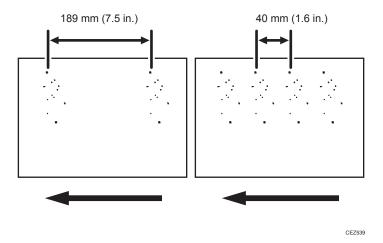
Colored Spots

Colored spots appear at 189 mm or 40 mm (7.5 inches or 1.6 inches) intervals.

(a) Colored spots appear at 189 mm (7.5 inches) intervals

The drum is scratched or stained.

The charge roller is scratched or stained.

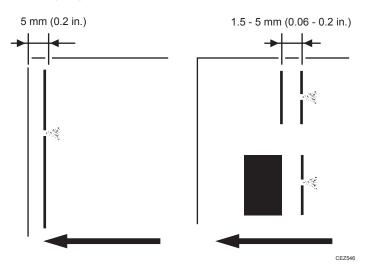
Toner Scatter (2)

Parts of a line exhibit splatter. This may occur in a line that is 5 mm (0.2 inches) or less from the leading edge, or in a line that is 1.5 to 5 mm (0.06 to 0.2 inches) from an image on the side of the image facing the trailing edge.

This may occur when printing lines on coated or other slippery paper.

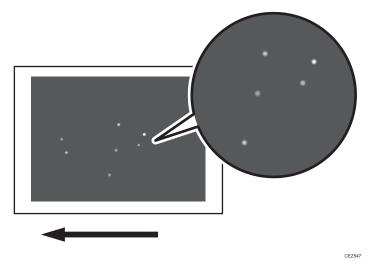
Colorless Spots

Colorless spots appear in solid-filled areas.

If the toner contains small clots, they fail to be transferred, producing colorless spots.

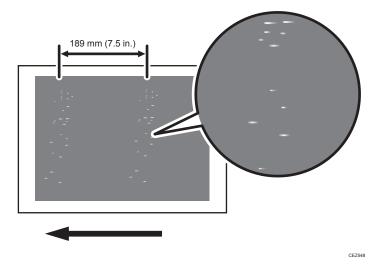
White Dots/Lines

White dots or short lines appear, spaced at intervals of 189 mm (7.5 inches) in the direction of the paper feed.

The photoconductor unit is stained.

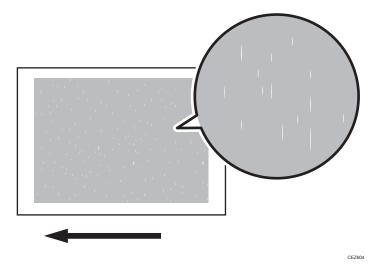
Vertical White Streaks

White streaks of 1 to 8 mm (0.04 to 0.3 inches) long and perpendicular to the paper feed direction appear.

One of the charge rollers is soiled.

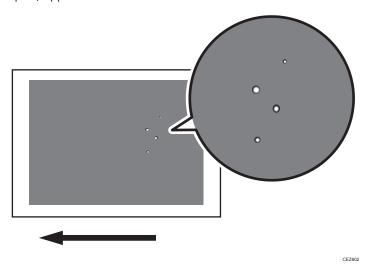
Blister-like White Spots

White spots 0.3–0.5 mm (0.01–0.02 inches) in diameter surrounded by denser spots (blister-like white spots) appear.

This may occur if a solid image is printed on coated paper, if a solid image is printed during duplex printing, or if printing is done at low temperature.

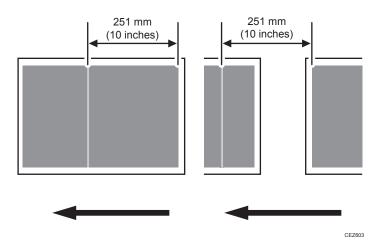
Vertical Glossy Lines

Glossy lines perpendicular to the paper feed direction appear.

Glossy lines perpendicular to the paper feed direction may appear 251 mm (10 inches) from the boundary of the margin and the solid image (in the direction opposite to the paper feed direction).

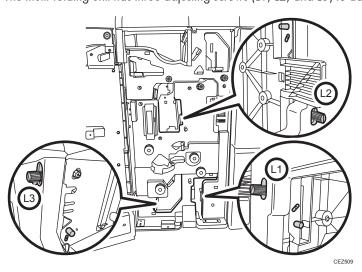
Adjust the deviation.

The multi-folding unit has three adjusting screws (L1, L2, and L3) to adjust deviation.

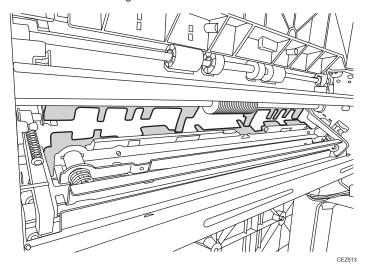
4. Wipe the tip and top of the blade with a soft dry cloth.

Be careful not to damage the blade.
